Manhole Inspection Summary

Manhole # S17EE2024MH

Location Address: **5801 LOCHLEA RD**

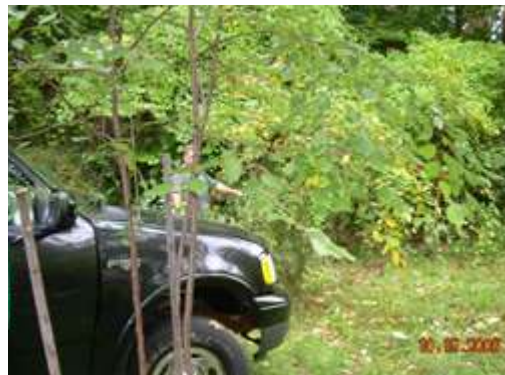
Location View

Chris standing by manhole location.

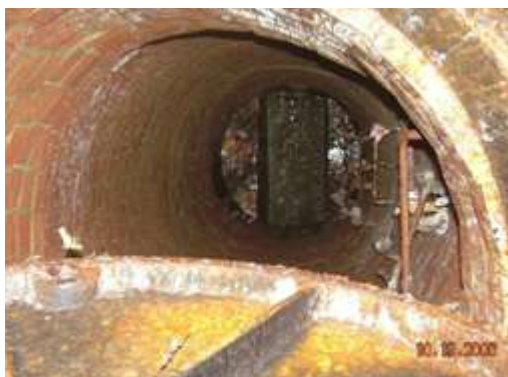
Top View

Corroded steps. Evidence of surcharge - Bench debris.

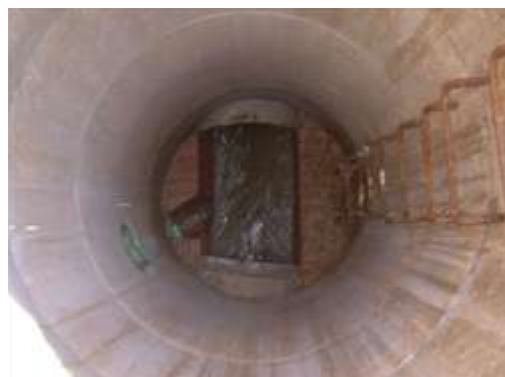
Top View

Evidence of surcharge

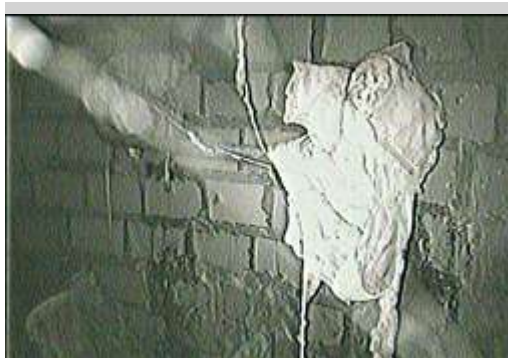
Barrel infiltration.

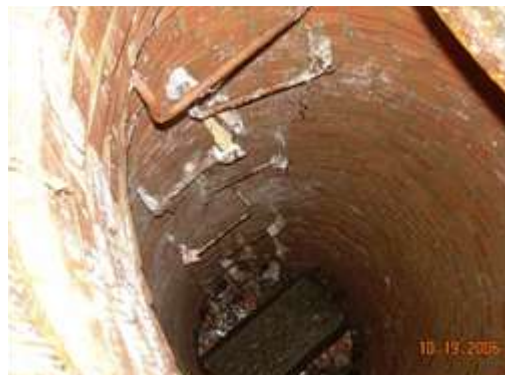
Defect

Adjustment and Corbel infiltration - other side.

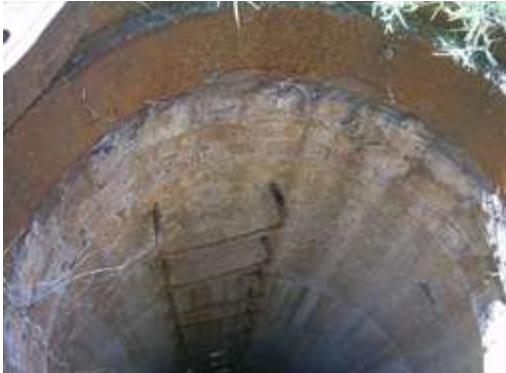
Defect

infiltration in mh

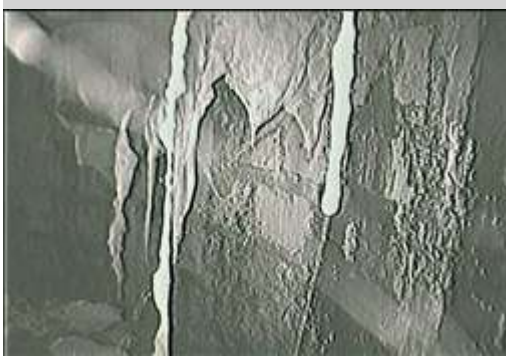
Defect

Barrel infiltration.

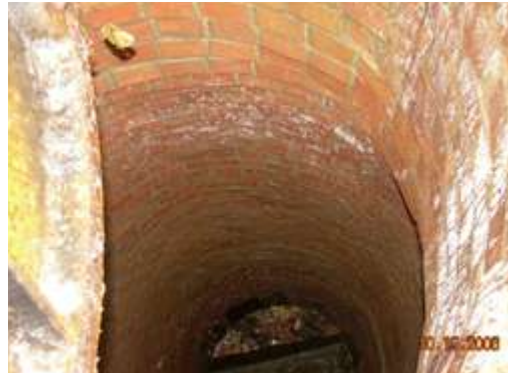
Defect

Adjustment and Corbel infiltration.

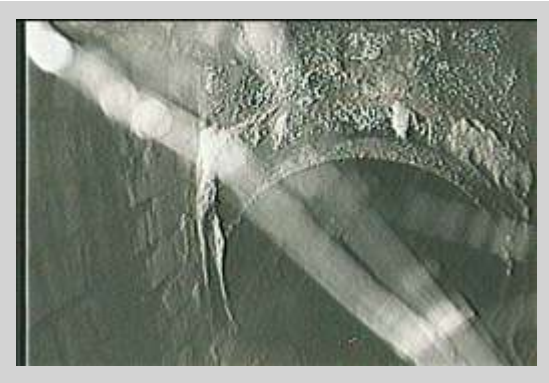
24 in. Circular Gravity Sewer Pipe Out @ 12 O'Clock

Infiltration: **Evidence** Pipe Seal Cond: **Unknown**

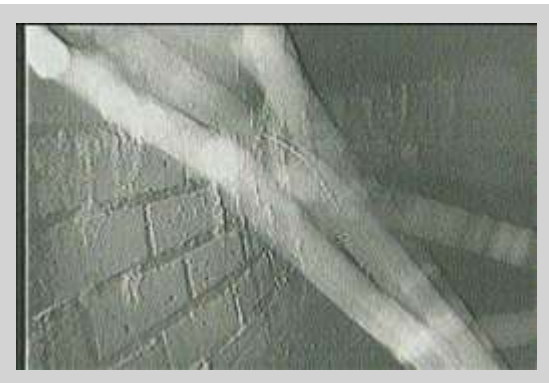
24 in. Circular Gravity Sewer Pipe In @ 6 O'Clock

THE STRUCTURE CURVES TO MEET
INCOMING PIPE. Channel leaks.
